Gold Embrittlement The Causes and The Effects

Presented by Glenn Little
WB4UIV

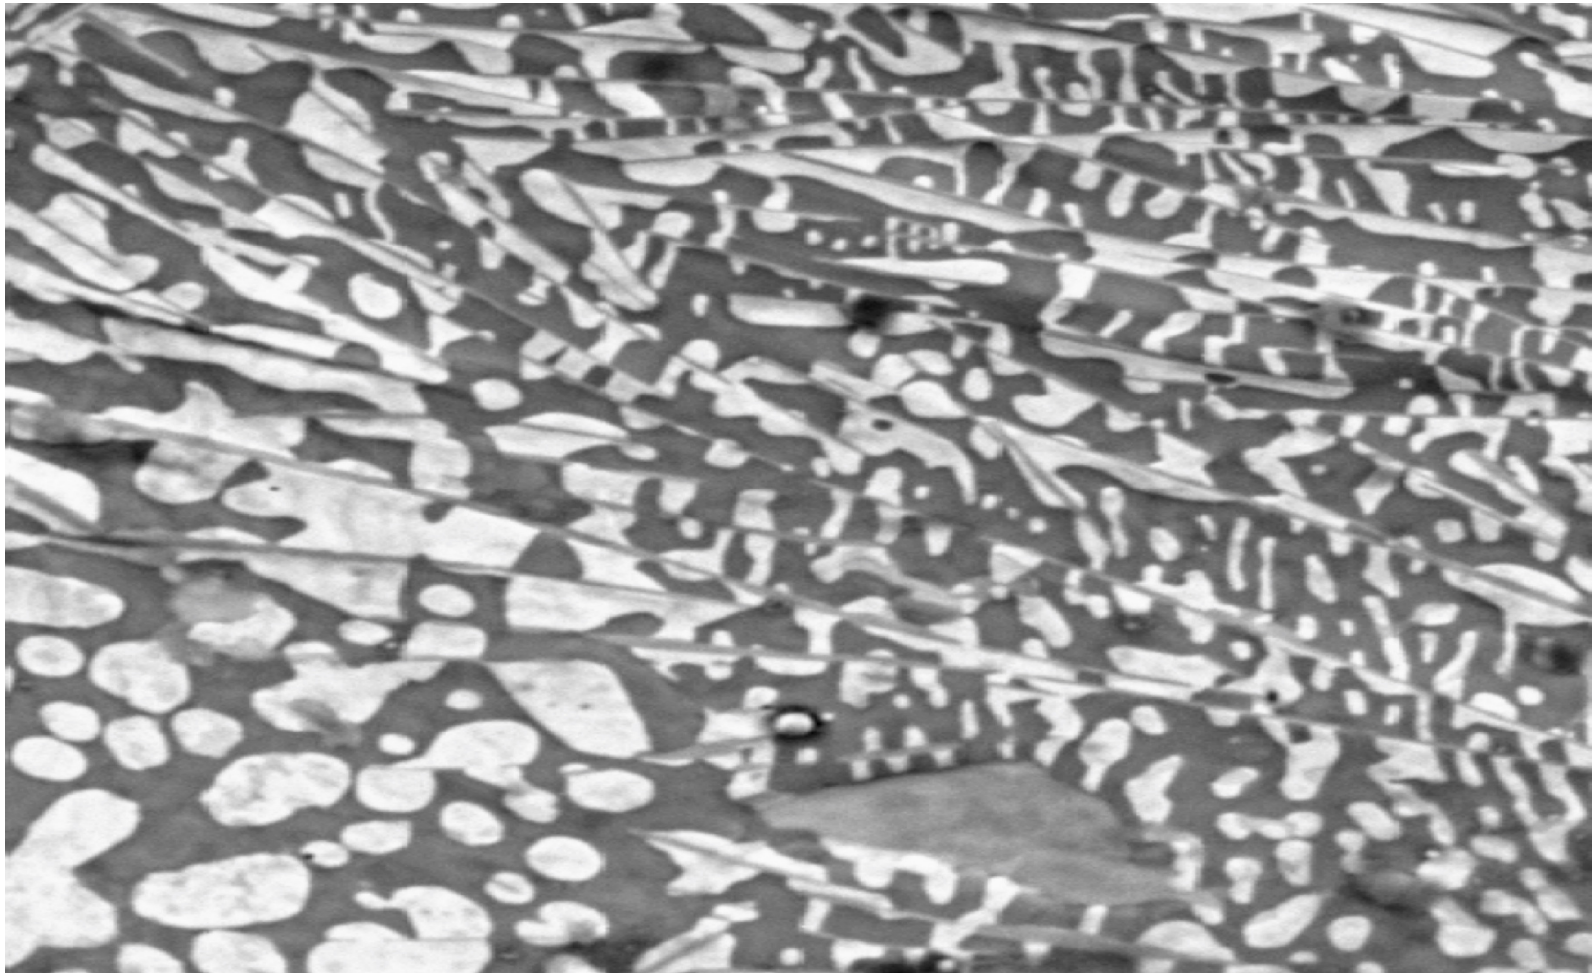
Gold Embrittlement in Eutectic Tin-Lead microstructure

- When solder cools, different crystalline structures are formed in the cooling process
- When sufficient gold is present, AuSn_4 is one of the structures
- This structure is very brittle, where as the other structures formed are more malleable
- It is this brittle structure that causes the problem
- With stress, the solder will fracture at this brittle area

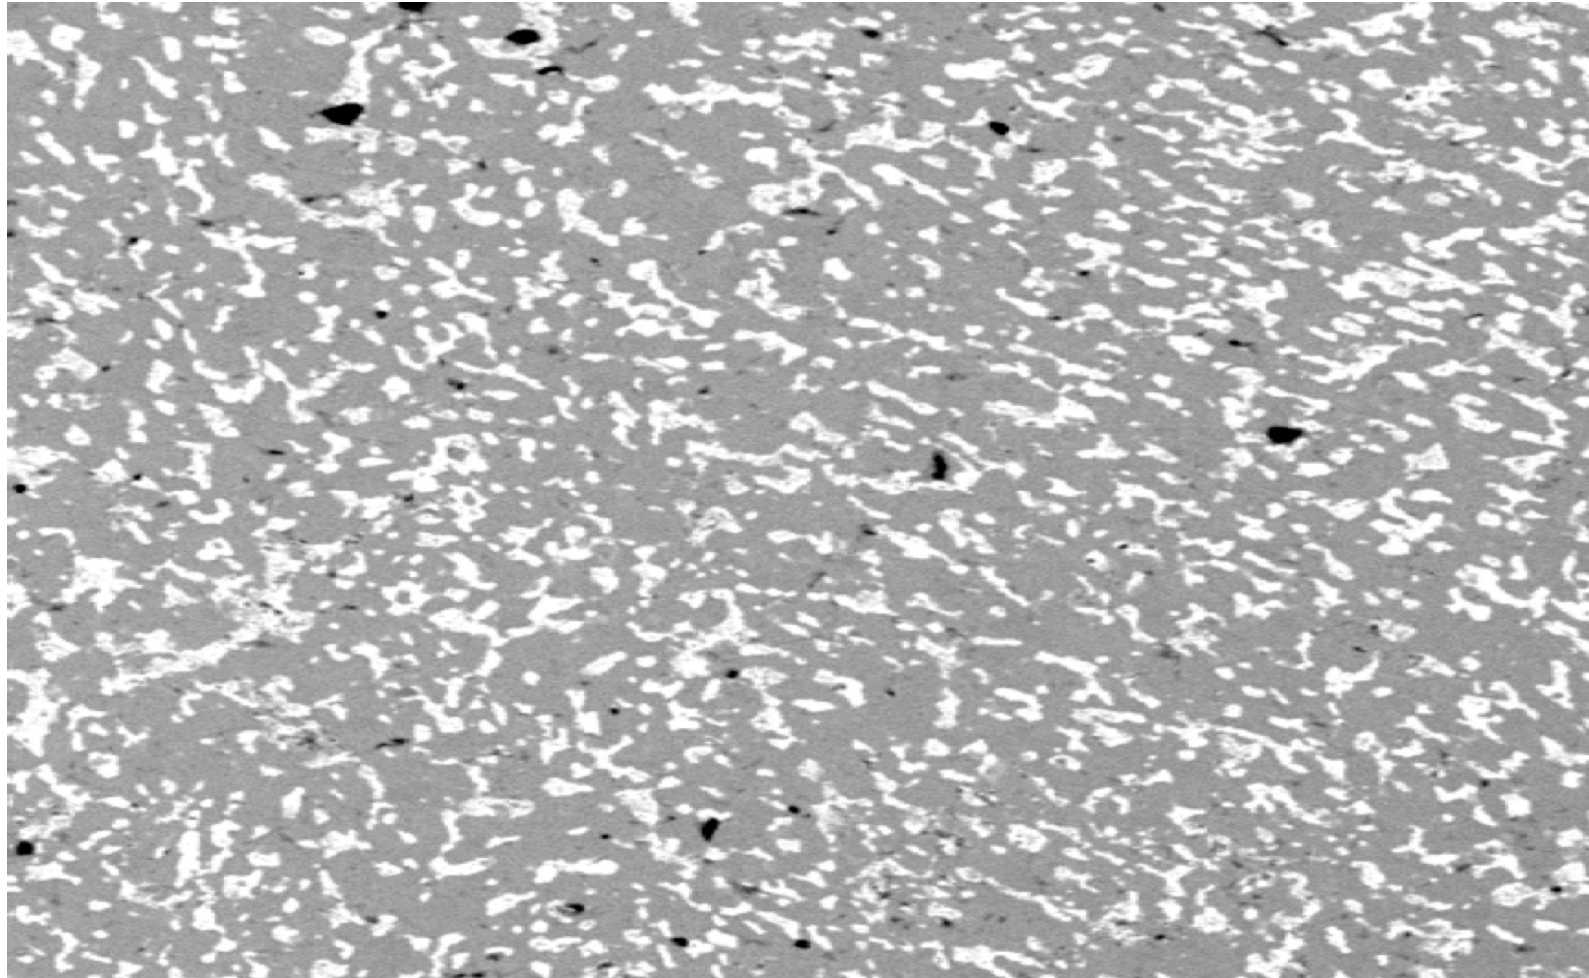
Normal Eutectic Tin-Lead Solder Microstructure
